What if pieces of the balcony above fall down? Practical case and near tragedy.

It is the phenomenon of the "breaking down" of the floors, very widespread and often neglected.

Ing. Cristian Angeli 06/30/2022

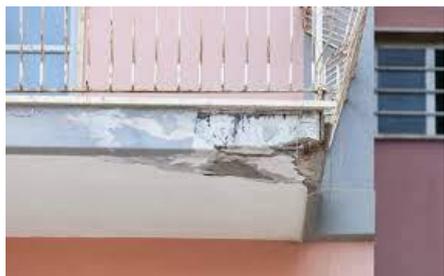
large piece of the balcony above fall to the ground a little further on . In reality it was "only" plaster, mixed with "shreds" of brick, with an estimated weight of about 80kg which, if they had fallen on her head, would have tanned it badly.

In the specific case of the "lucky" lady, numerous cracks in the plaster of the balcony had been observed in the months preceding the posting, but they had not been reported and therefore, little by little, the infiltration of rain and the consequent oxidation of the iron bars. reinforcement of the joists, had determined the detachment of the plaster which, with its weight, had also torn pieces of the brick "pots" inserted in the slab.

Some are radical and involve the removal of degraded materials (due to the effect of humidity and the oxidation of the reinforcing bars), and the replacement with new products (usually glued polystyrene blocks), as well as with the application of a mesh of reinforcement and a subsequent layer of plaster. In this way the danger of detachment is eliminated and the original aesthetic conditions are restored.

In other cases, it is possible to intervene, provisionally, by applying visible nets which have the effect of retaining the pieces and therefore preventing them from overwhelming people or things when they fall.
